NPIC/CSD-43/66  
23 JANUARY 1966  
PAGE 13

FERRY CROSSINGS  
ROUTE 1, NORTH VIETNAM

NATIONAL PHOTOGRAPHIC INTERPRETATION CENTER

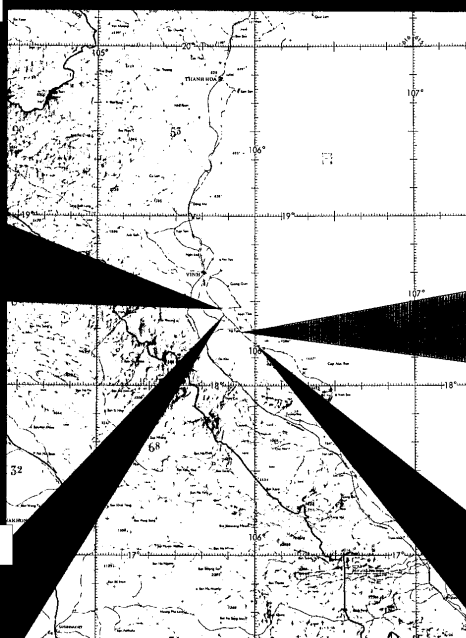
HA TINH  
FERRY CROSSING  
18-19N 105-55E

REVEALS A FERRY CROSSING AT 1819N 10555E, 1.5 NM SOUTHEAST OF HA TINH, JUST SOUTH OF THE DESTROYED HA TINH HIGHWAY BRIDGE OVER THE SONG NAI. A FERRY IS OBSERVED AT THE SOUTH LANDING. THREE SOUTHBOUND TRUCKS AND AT LEAST TWENTY PERSONNEL ARE OBSERVED ON THE SOUTH APPROACH TO THE FERRY CROSSING.

TRUCK
